# County of Greenville, South Carolina

## Gilder Creek Watershed Study

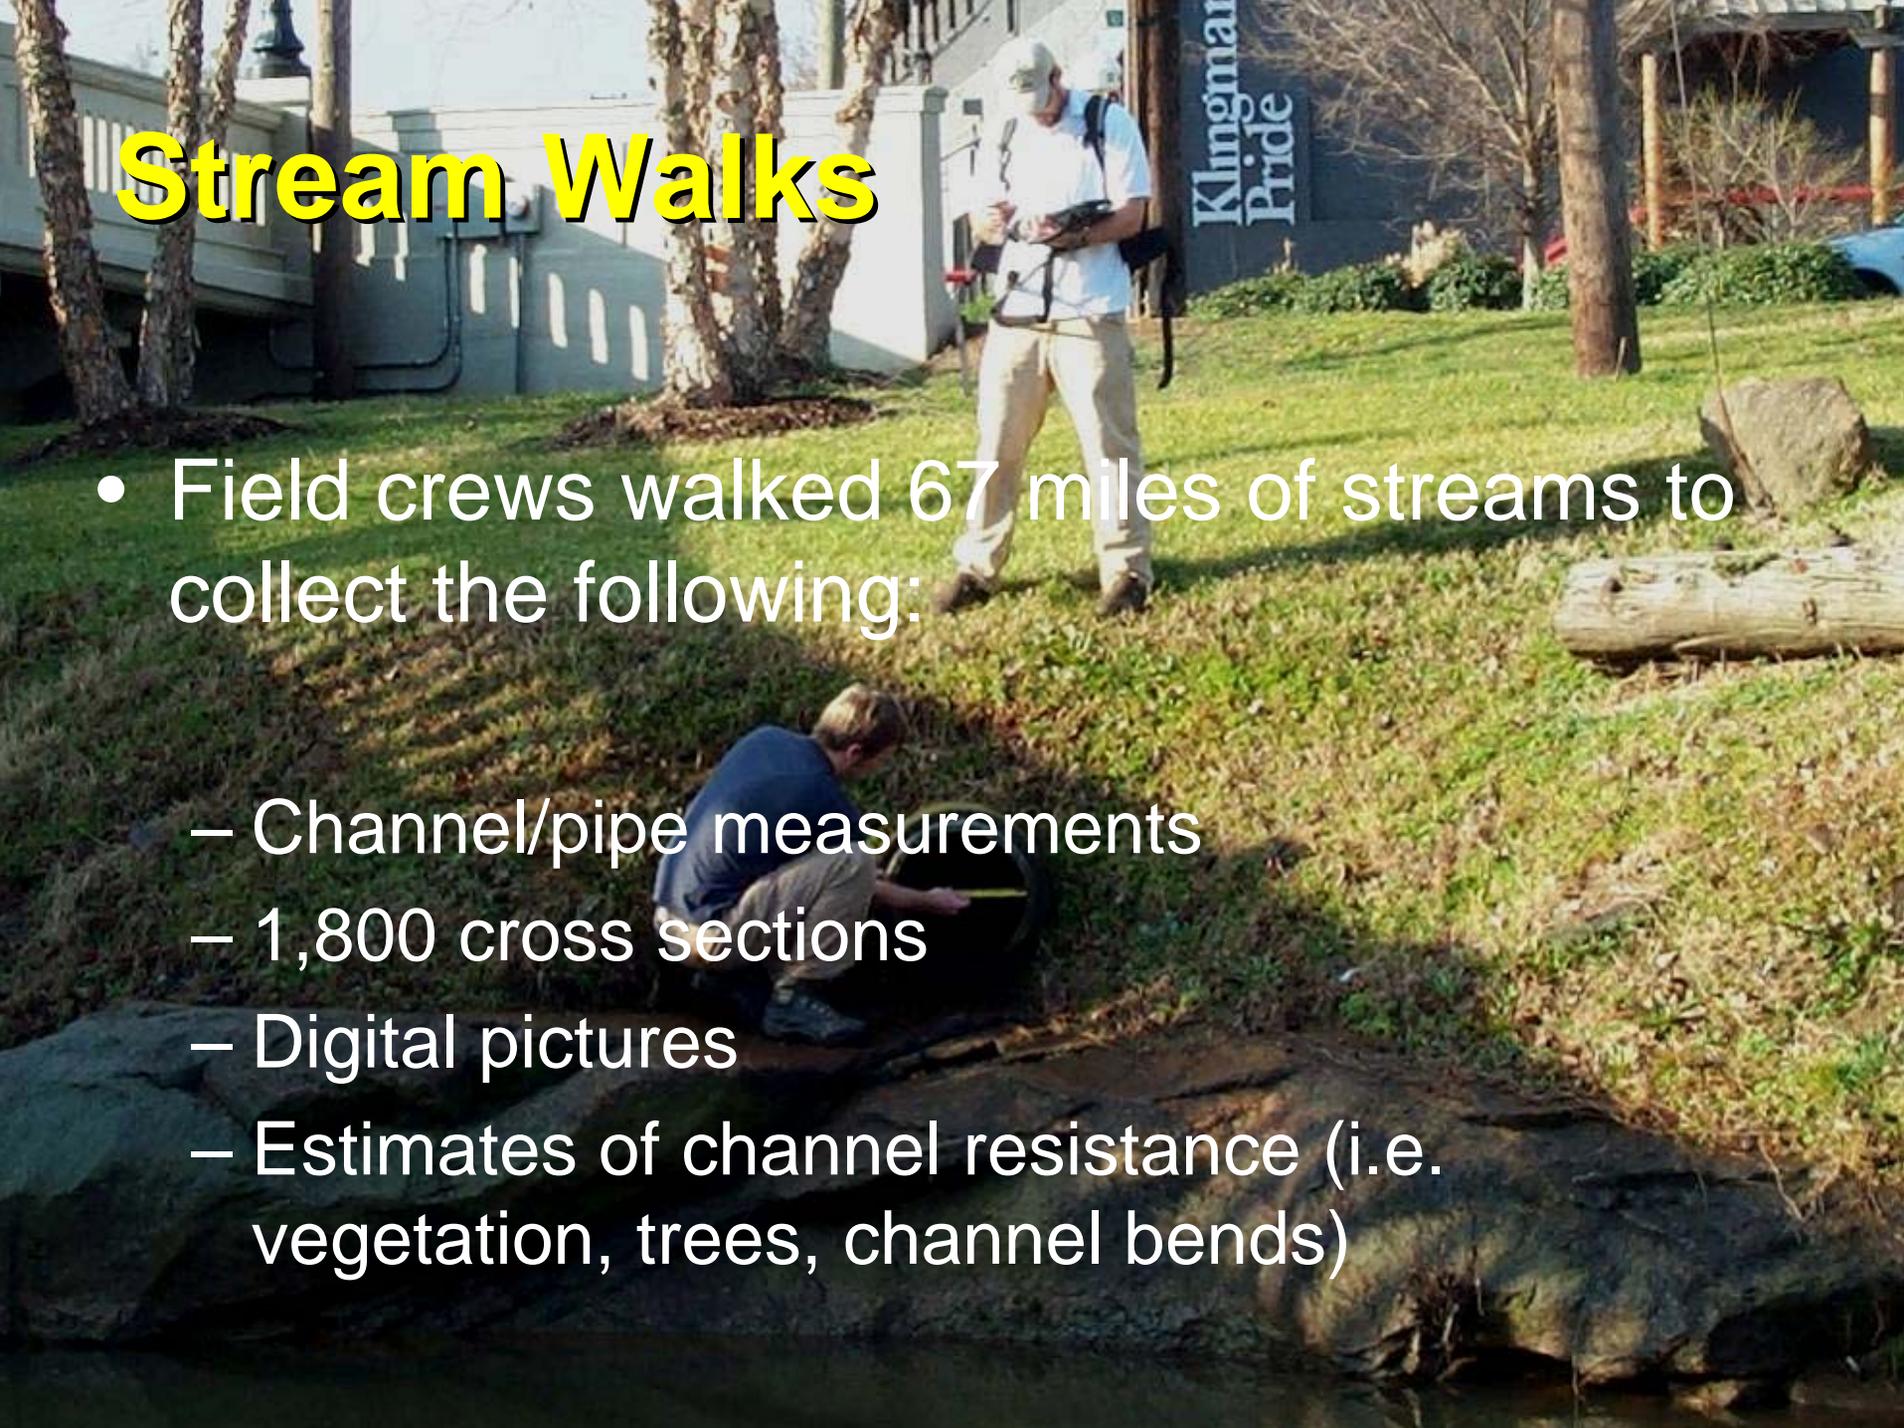
# Stream Walks

- Field crews walked 67 miles of streams to collect the following:
  - Channel/pipe measurements
  - 1,800 cross sections
  - Digital pictures
  - Estimates of channel resistance (i.e. vegetation, trees, channel bends)

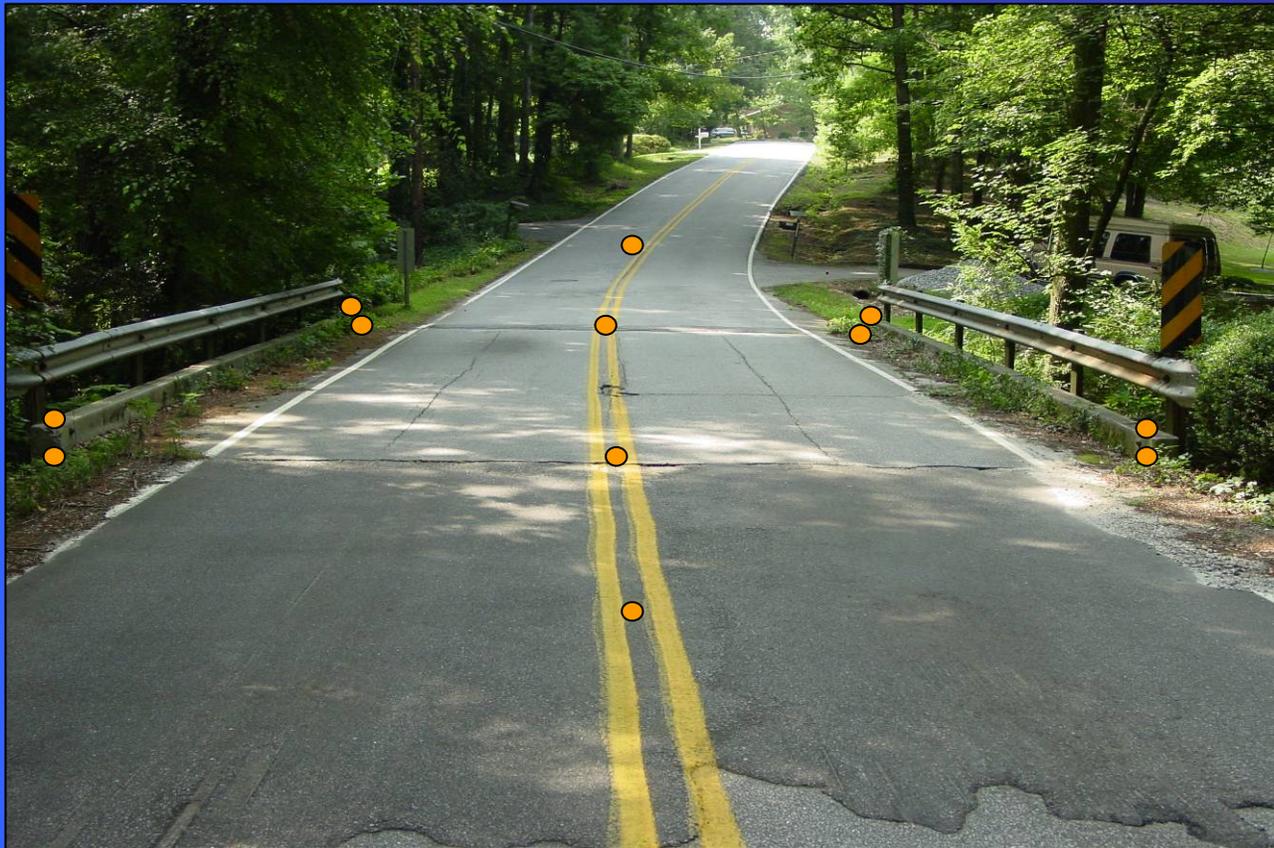
# Bridge/Culvert Survey

- Surveyed a total of 141 culvert and bridge crossings

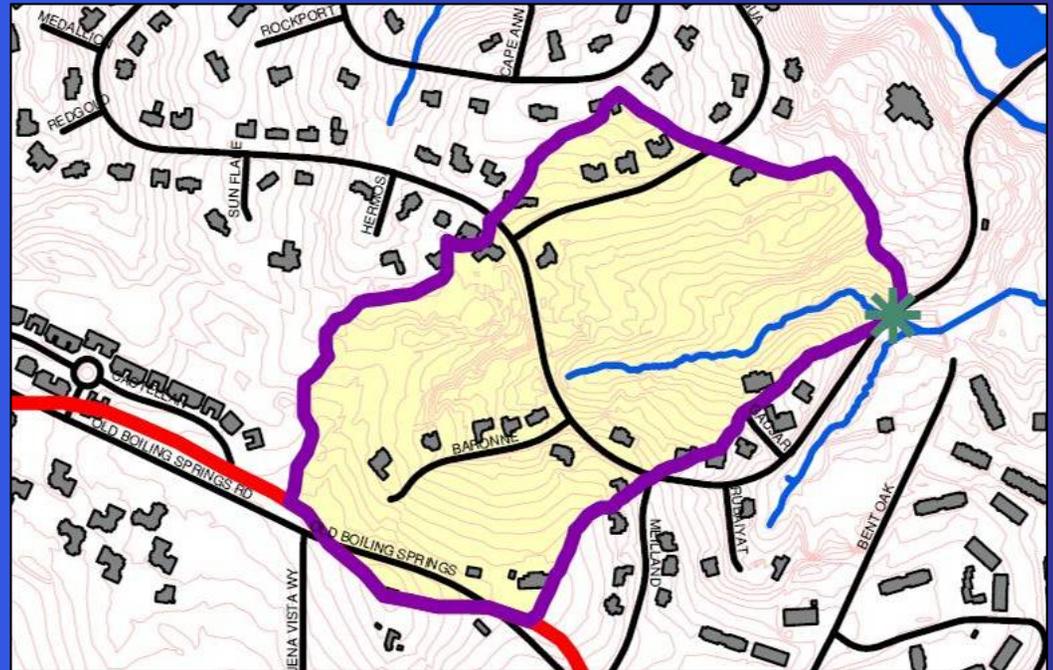
# Hydrologic Modeling

- Divided the basin into 196 sub-watersheds to predict the amount of storm water runoff during rainfall events using:

- Drainage area
- Soils
- Landuse

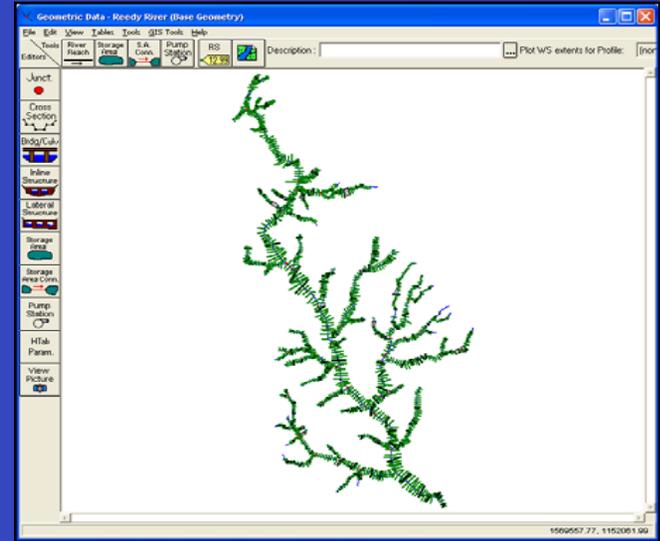
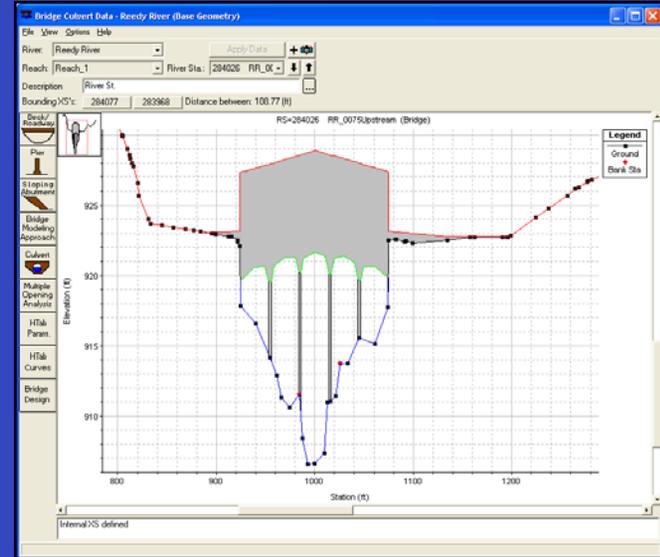
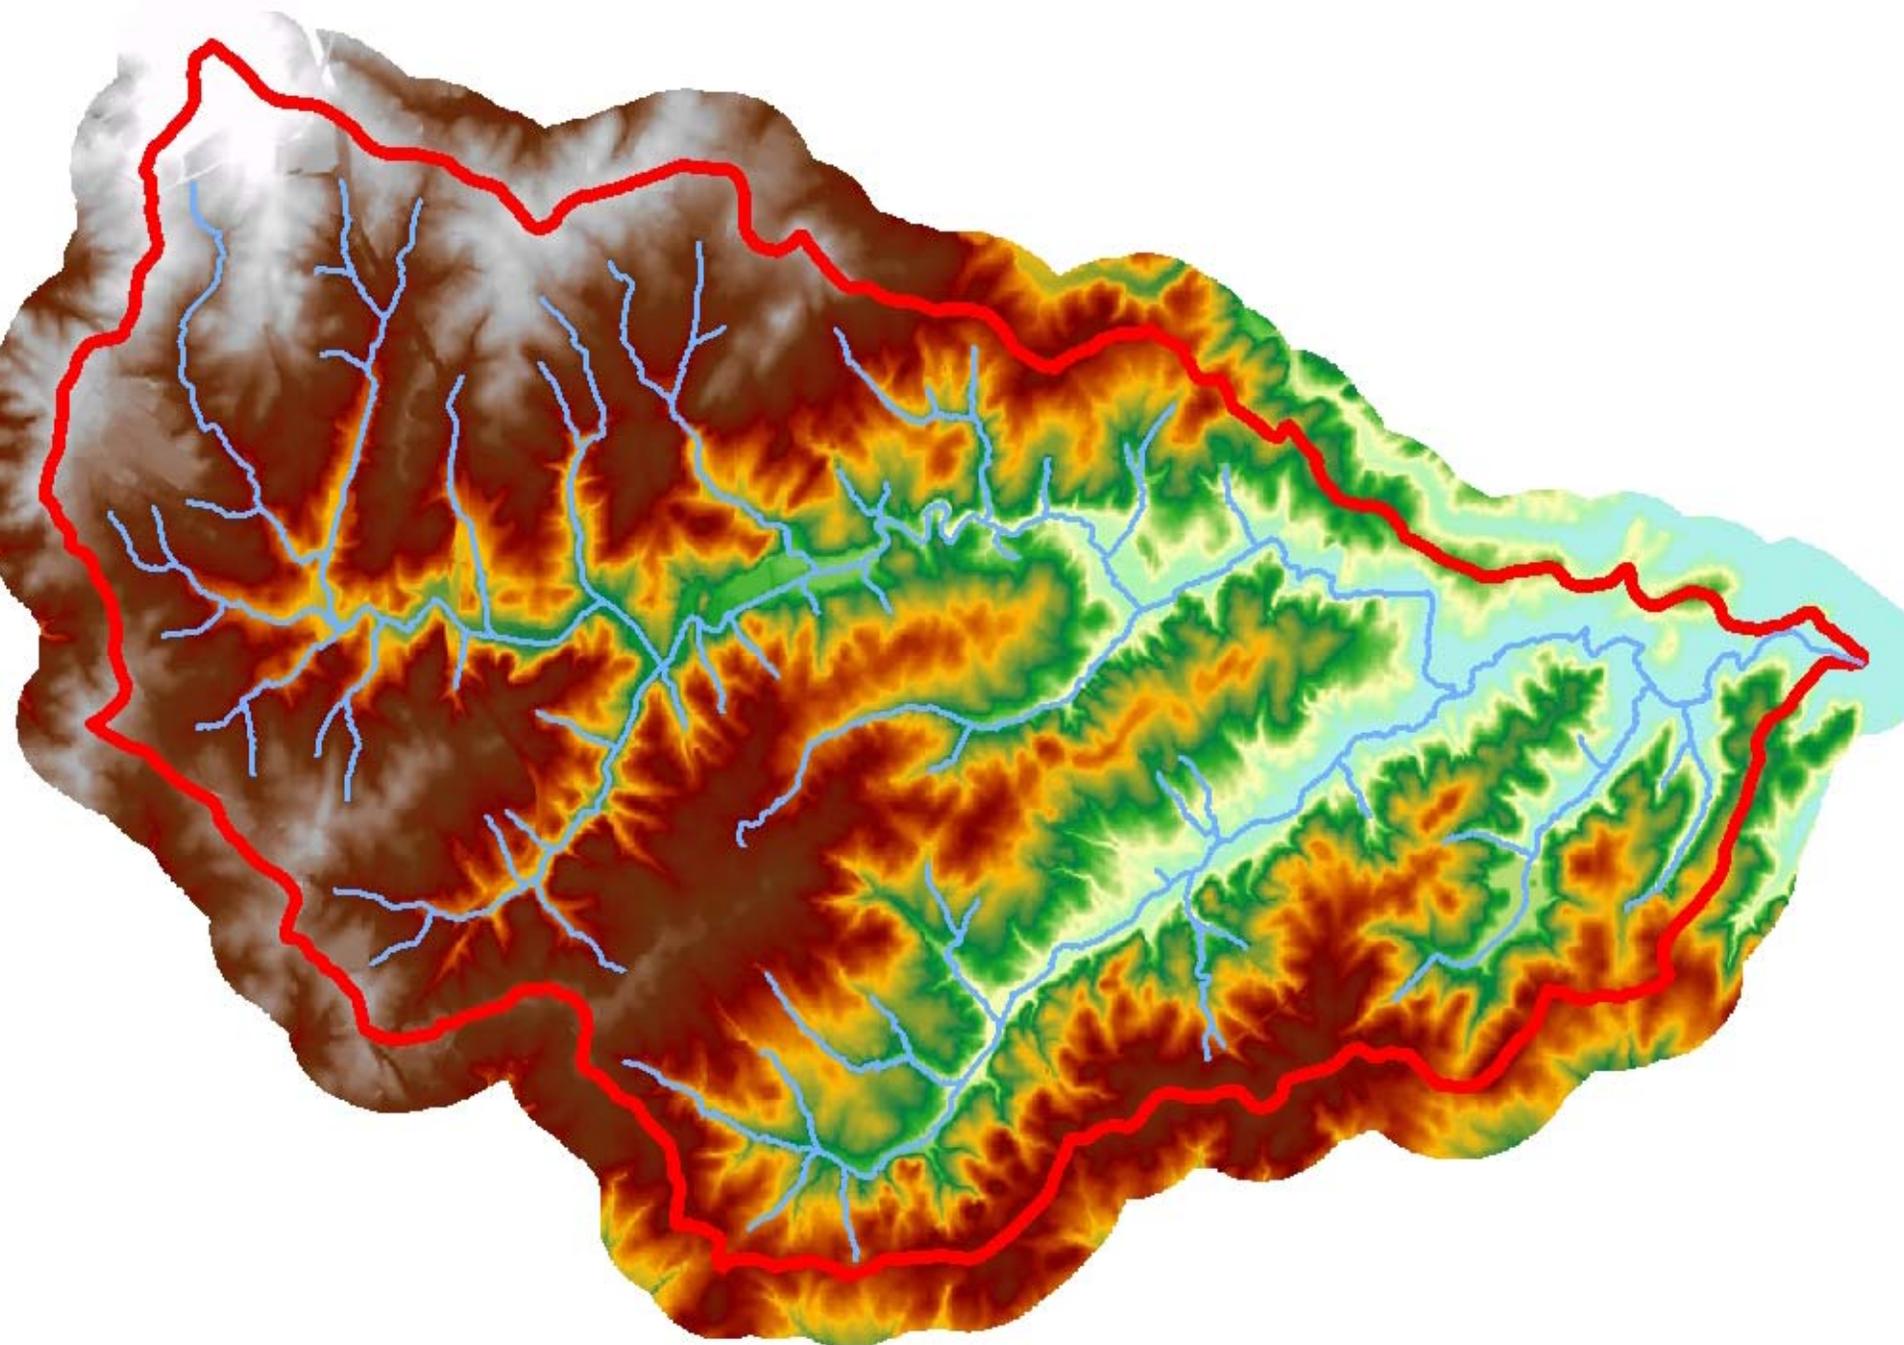
# Hydraulic Modeling

- Predicted water surface elevations using the following:
  - Bridge/culvert survey data
  - Runoff predicted from hydrologic modeling
  - Channel and floodplain geometry
  - Channel slope
  - Channel resistance (i.e. vegetation, trees, channel bends)

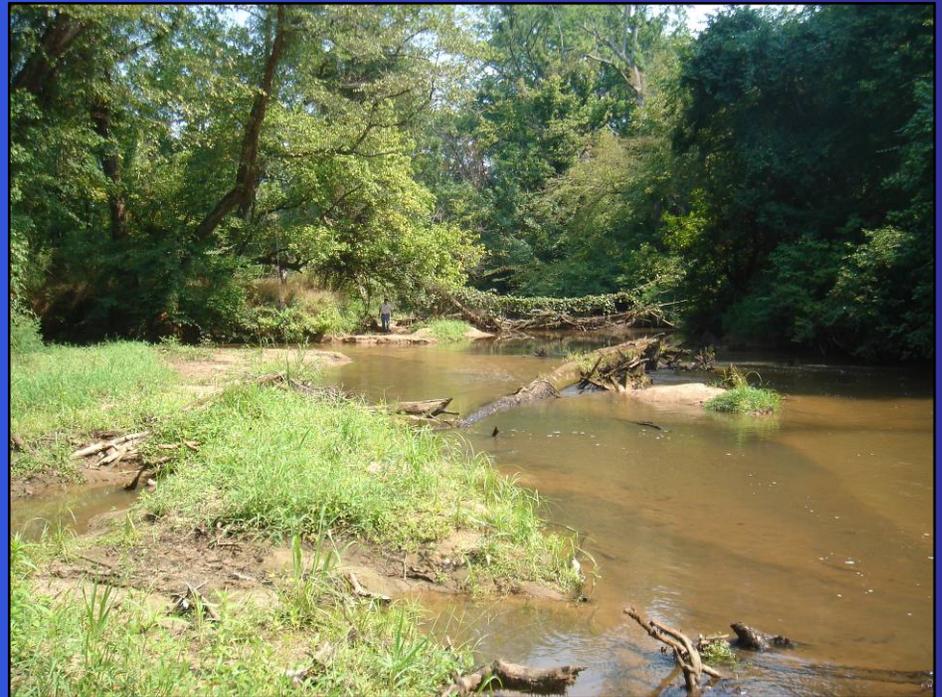
# Initial Validation Results

- Model vastly under predicted flooding as shown in TS Jerry photos, particularly on east side of basin
- Flooding much lower than 100-year FEMA mapping
- Performed field assessment, revised model inputs, little improvement

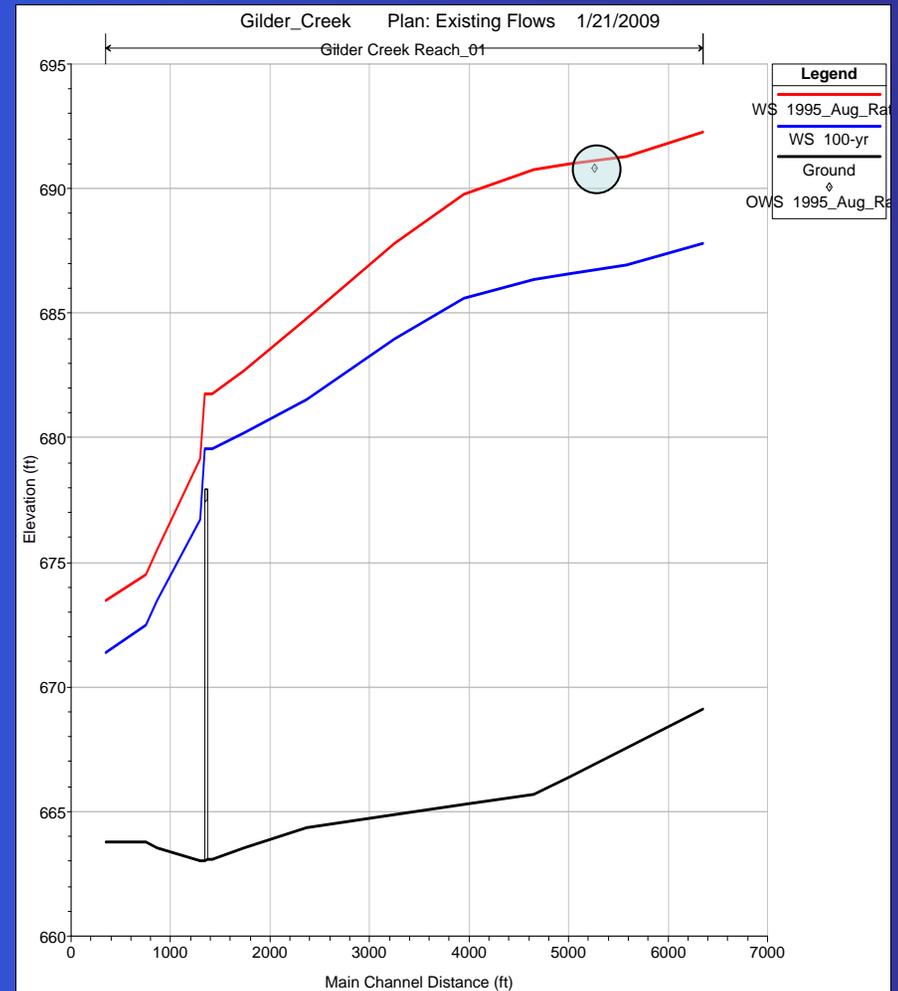
# Final Validation

- Matched HWMs within 0.2 -1.0 feet
  - Kingswood Circle
  - Lee Vaughn Road
- Model inputs provide representative results for other events

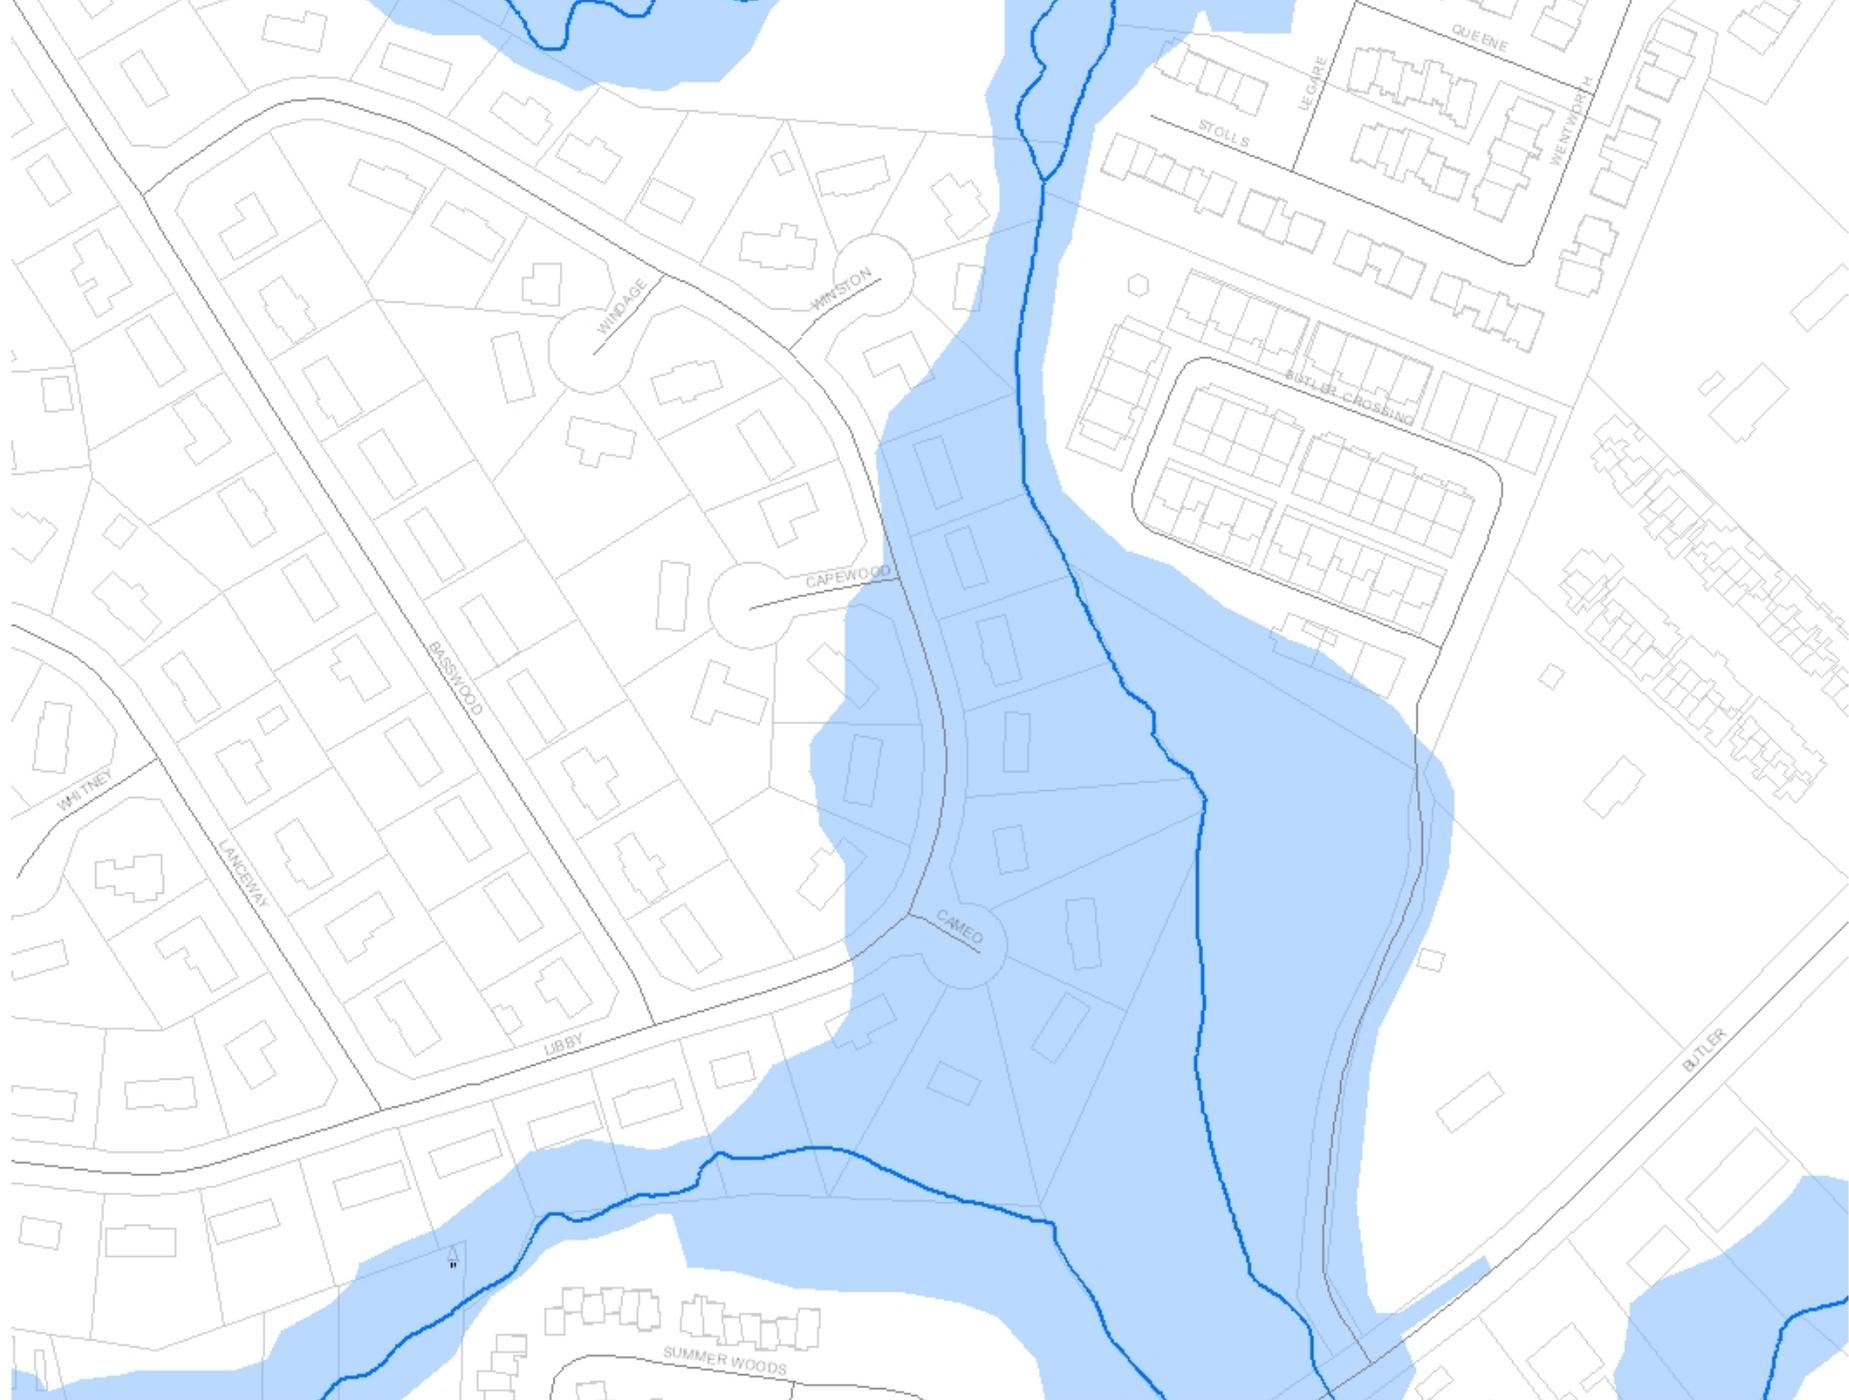
# Mapping Assessment

- Previous study adjusted watershed characteristics to match photos, we adjusted (corrected) rainfall
- Previous study assumed TS Jerry equivalent to 100-year storm, we believe it was much, much greater

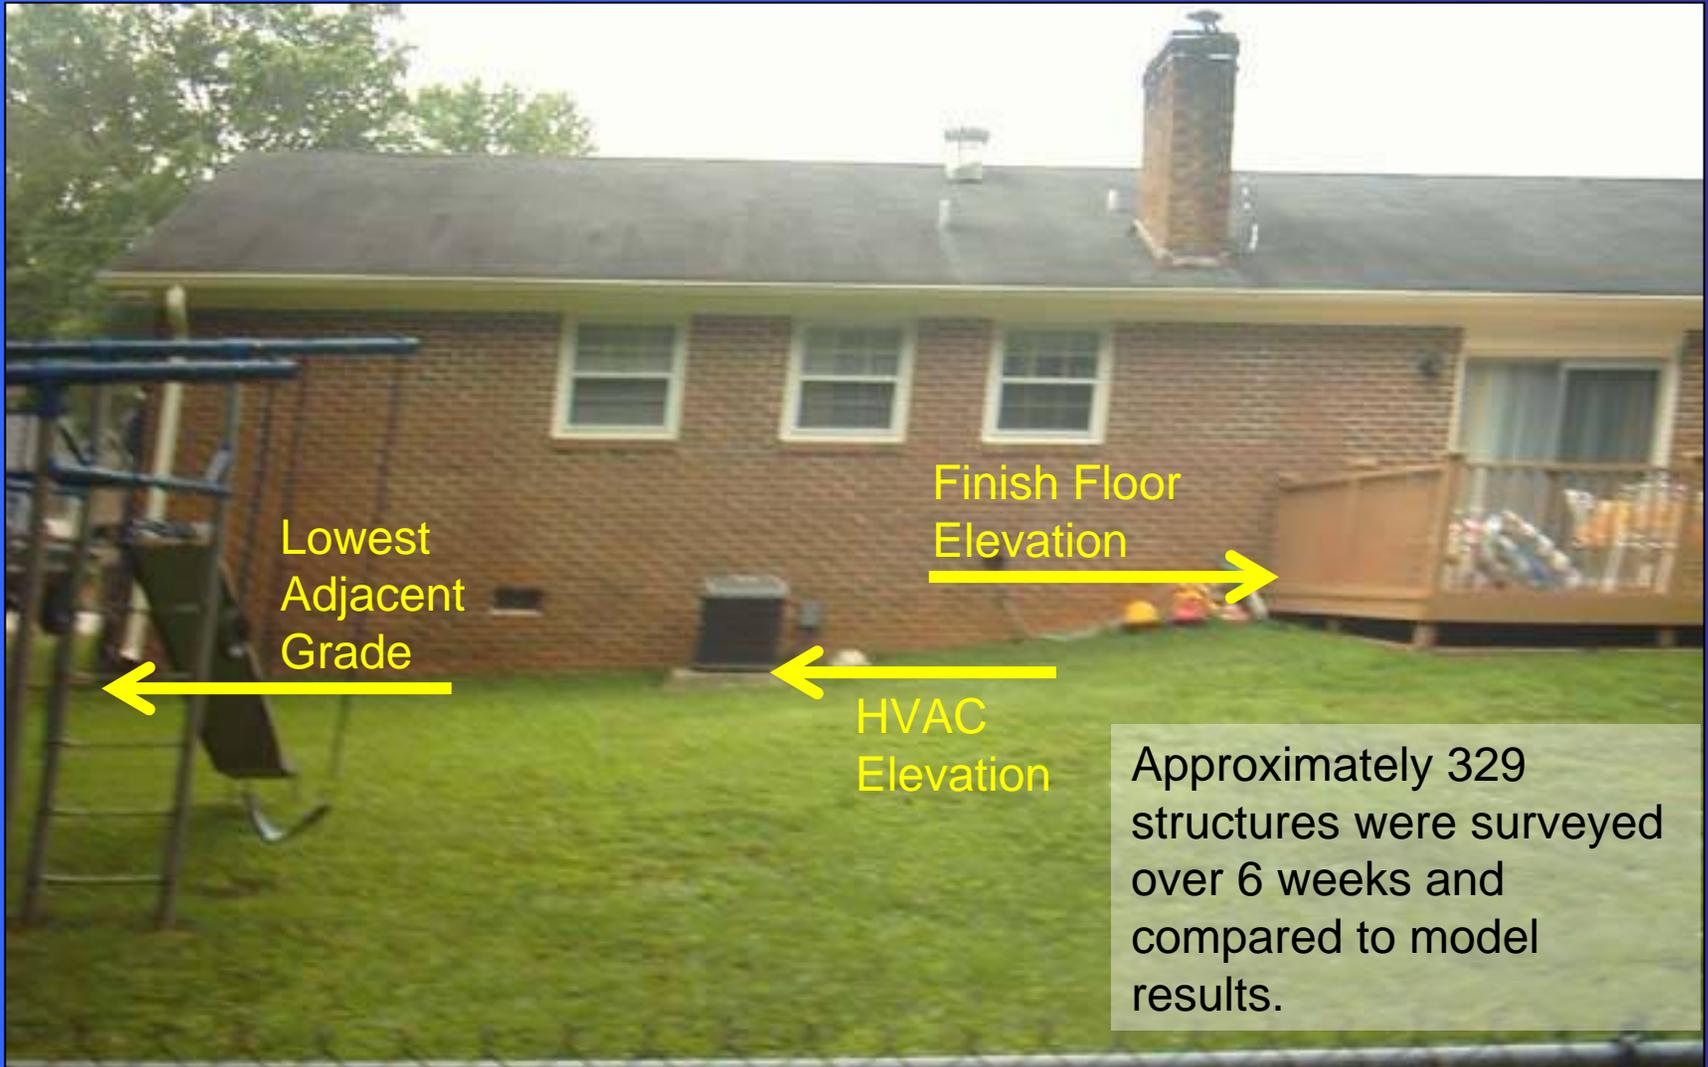
# Residential Structure Survey

Lowest  
Adjacent  
Grade

Finish Floor  
Elevation

HVAC  
Elevation

Approximately 329  
structures were surveyed  
over 6 weeks and  
compared to model  
results.

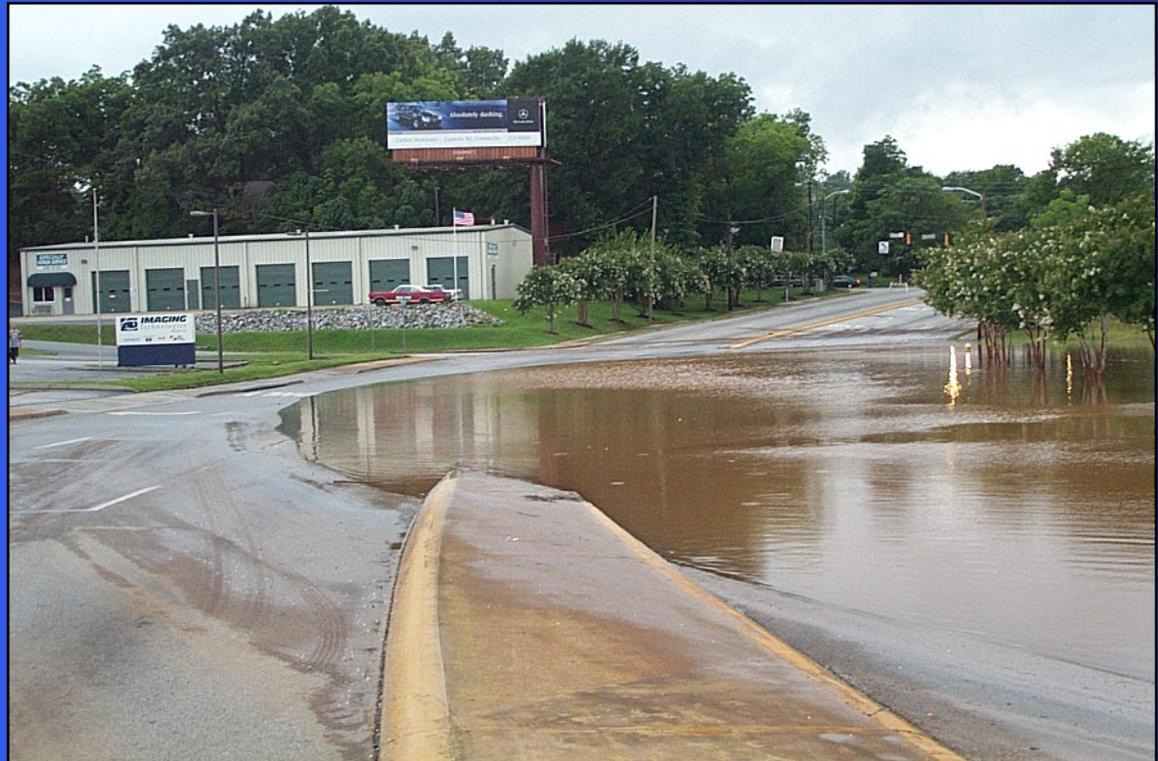
# Results

- Yard flooding
- Culvert/bridge overtopping
  - 8 County roads (2-year storm)
- Structures at risk during flooding
  - 30 homes (100-year storm)

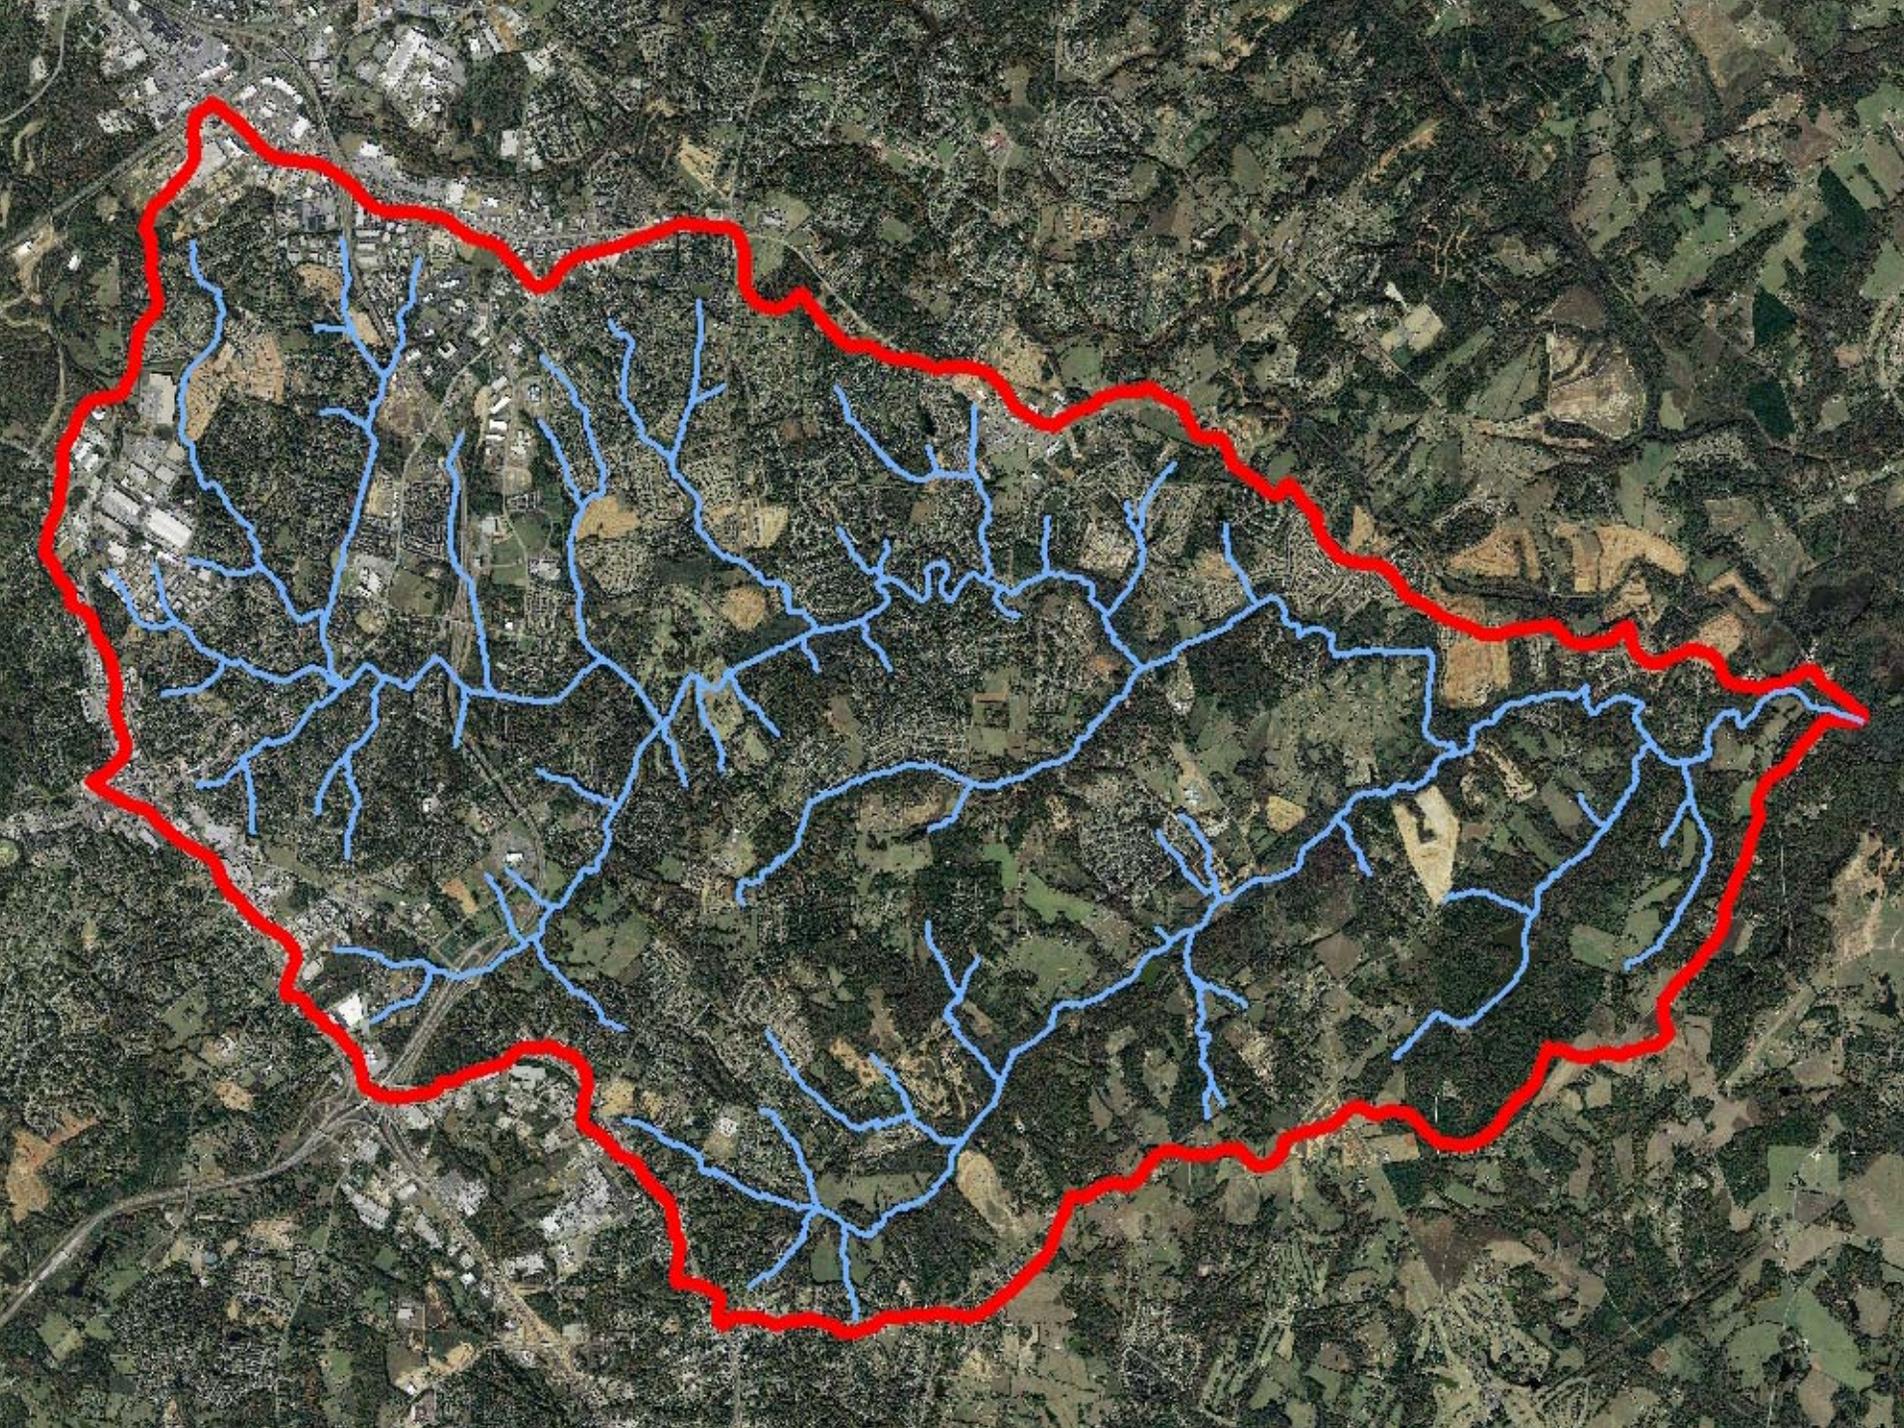
# Alternatives Analysis

- Based on initial evaluation, analysis will focus on on more localized solutions for **western half** of watershed such as:
  - Culvert/bridge improvements
  - House-by-house solutions

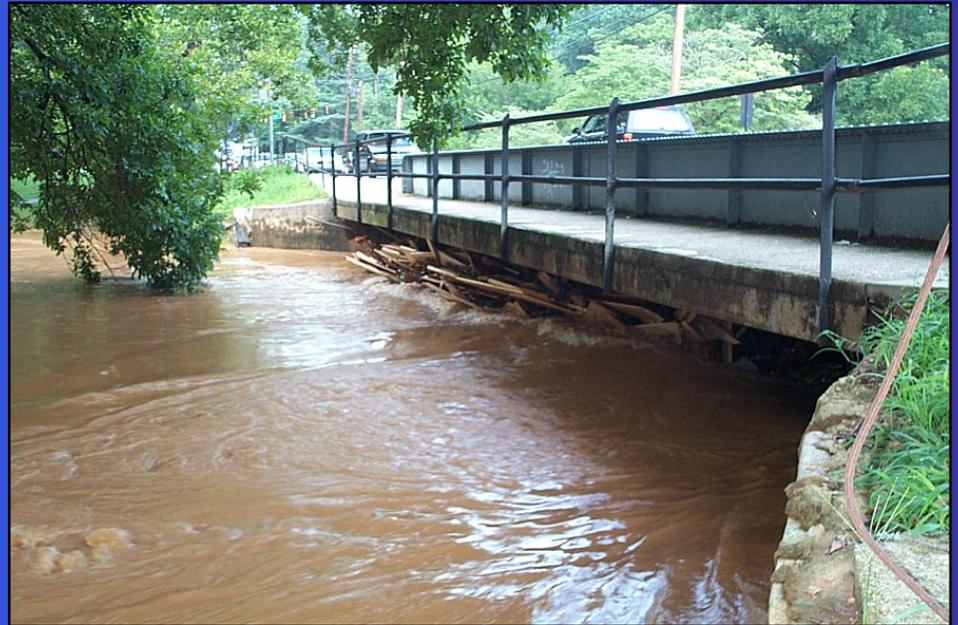
# Alternatives Analysis

- Culvert/bridge improvements
  - Evaluation of individual road crossings for potential improvements
  - Consideration given to roadways which eliminate or reduce access by emer. services

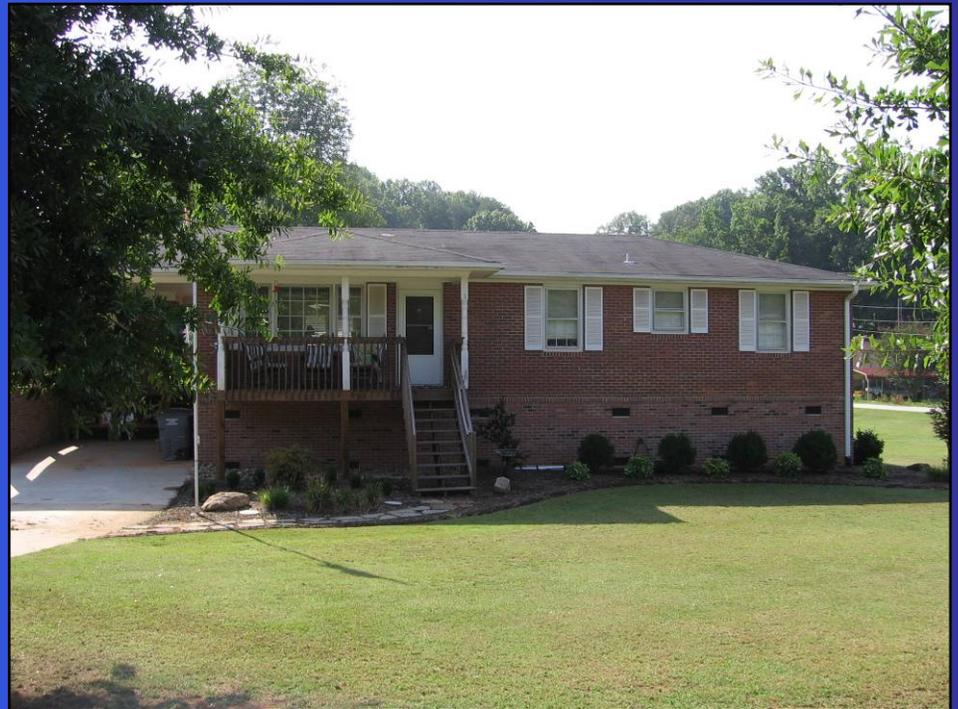
# Alternatives Analysis

- House-by-House Solutions
  - Flood protection systems
  - Elevated structures
  - Property acquisition

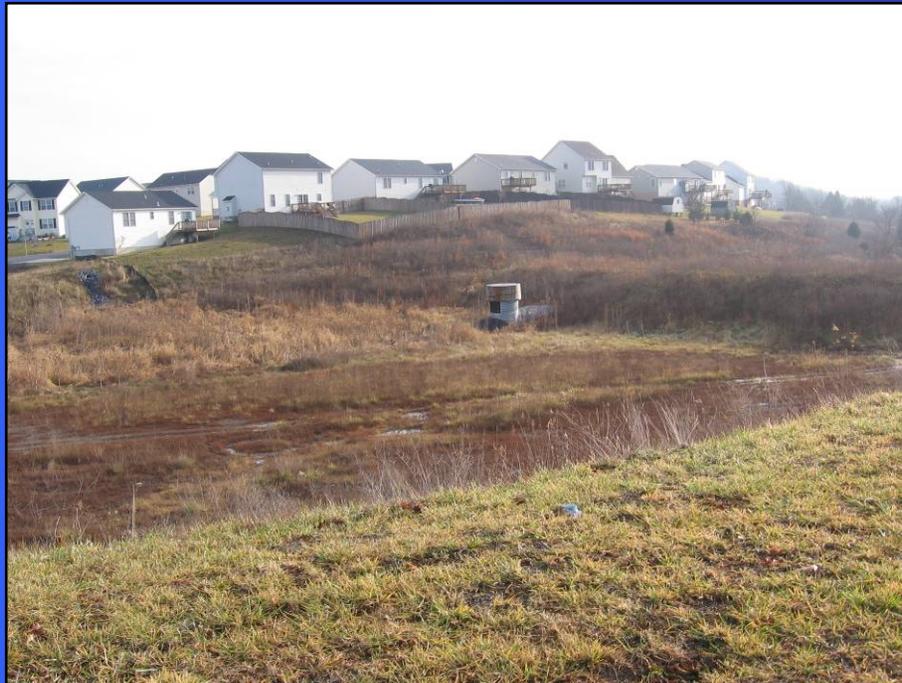
# Alternatives Analysis

- Regional detention and/or policy improvements to control future development in **eastern portion of basin**
